ISR 99

Strategic Intervention for the restoration
of the damages caused by the 1999 earthquake
at the Byzantine church of Aghios Petros
in Eastern Attica, Greece

Subproject's Progress

Athens, 15 & 16 March 2007

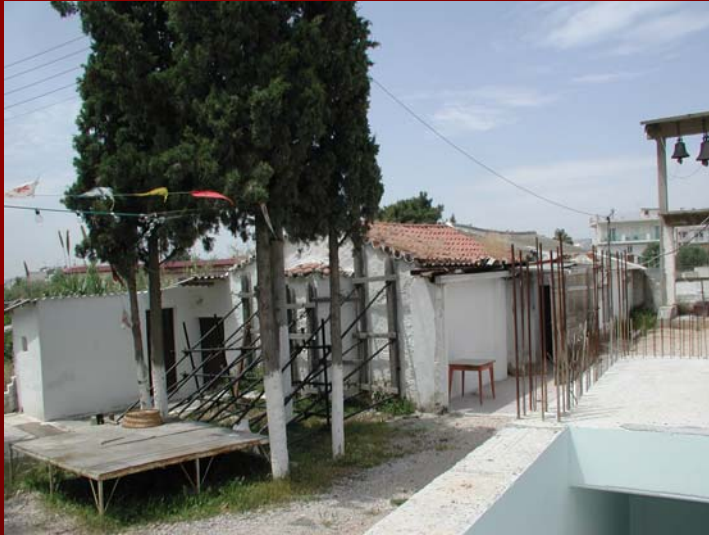
- General view from Northeast, illustrating some of the additions.
- The scaffolding supports the niche due to extensive cracks.

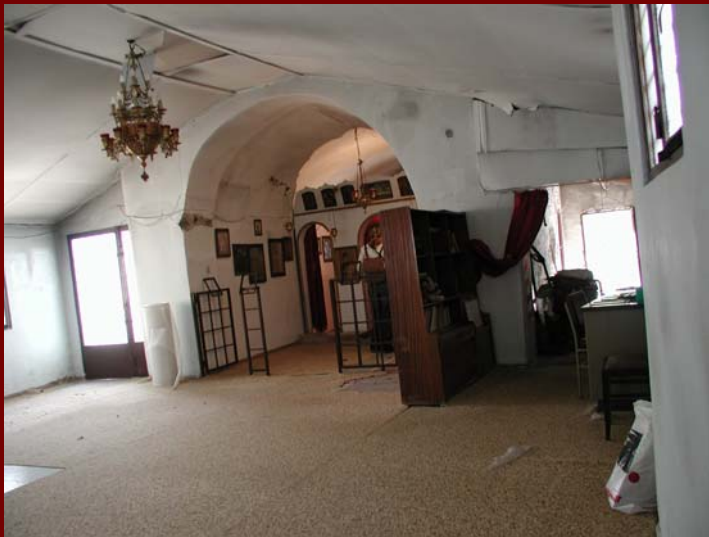
- General view of the interior with the inappropriate additions and the gap at the place of the demolished west wall

- Removal of all the newer and inappropriate additions
- Reconstruction of the demolished west wall.
- Improvement of the integrity of the walls and the vault, by sealing the cracks and reinforcing the masonry.
- Reinstating and improvement of the structural integrity (see further bellow)
- Replacement-Reconstruction of the tiled roof and application of water proofing layers with breathing capabilities.
- Reduce of the rising humidity at the foundation, by acceptable (for a monument) admixtures in the cement and pointing mortars.

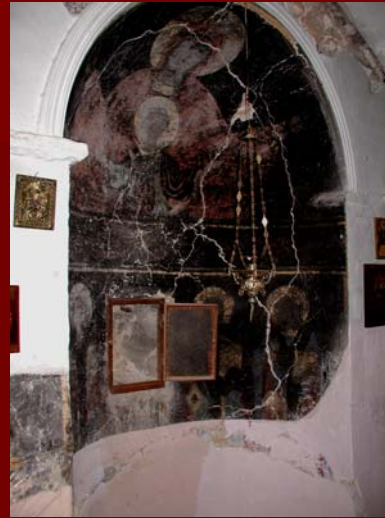
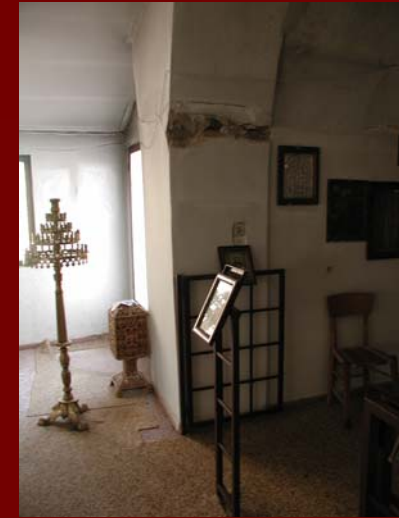
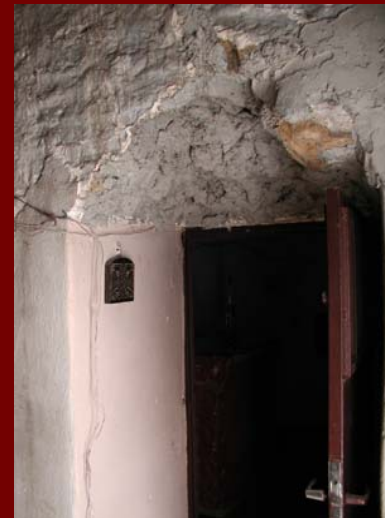
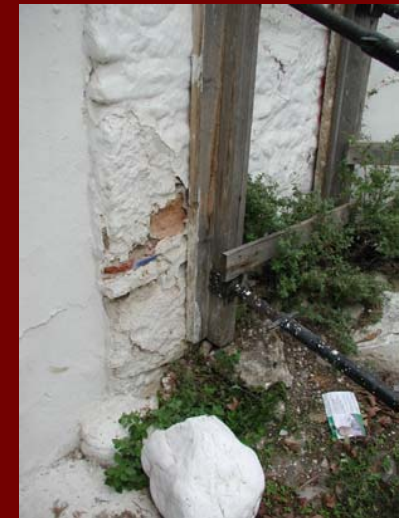
- Extensive cracks all over the niche at the eastern part. The severe condition was the reason for the supporting scaffolding at the east part, erected by the 1st Ephorate for Byzantine Antiquities.
- Serious cracks at the side long walls, especially near the demolished part near the SE corner.
- The west wall was totally and illegally demolished in early 1980's to expand the interior westwards.
- A door was opened near the SE corner by demolishing part of the south wall.

- Rather weak, shallow foundation on an inhomogeneous ground (partly due to the close proximity to the nearby creek)
- Poor and mixed quality of the building material
- Later interventions to the building (opening of a door near the corner, removal of one of the western transverse wall) that affected the symmetry and conservative character on which such modest structures rely
- The fairly local, recent (September 1999) earthquake in the region of Mt. Parnitha

- Reversal all later modifications in the structure of the church.
 - Rebuilding the west wall
 - Securing its connection to the lateral walls
 - Closing the side door at the south east corner
- Increase of the stiffness of the church in the transverse direction
 - Inserting a stainless steel tie-rod in the western wall
- Grout injection in all stone masonry in order to increase the cohesion and strength of all load bearing elements
- Repointing of all exterior masonry after removing the existing plaster
- Placement of two wooden beams atop the lateral walls, and fixing them with metal connections to the walls
- Strengthening of the church foundation by constructing a reinforced concrete beam along the perimeter

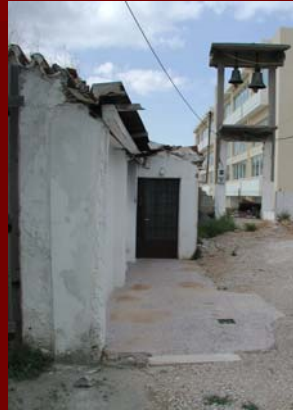
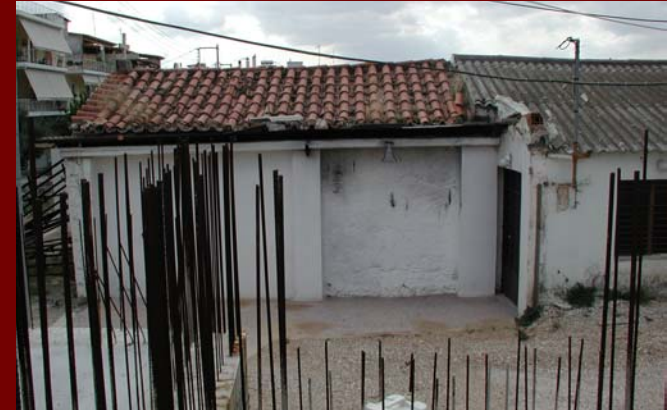
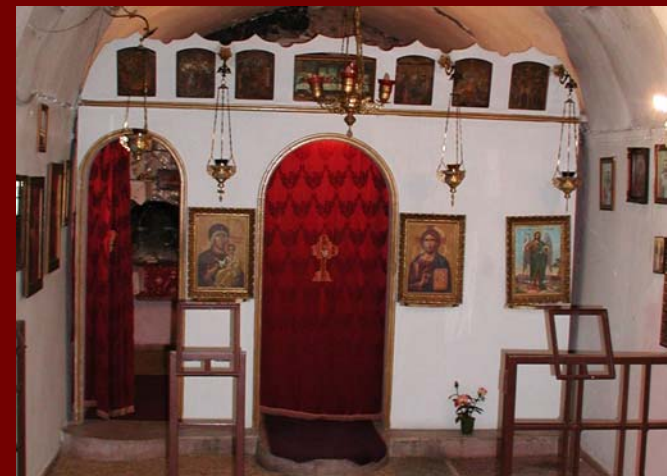
- Many non sympathetic interventions in the interior destroyed the original morphology. Most areas with wall paintings have been covered with a newer plasterwork.
- An icon screen wall was erected in the middle of the nave with inappropriate morphology.
- Extensive additions around the historic building eliminated its integrity and appearance.
- The poor quality materials used on the additions deteriorated the effect.

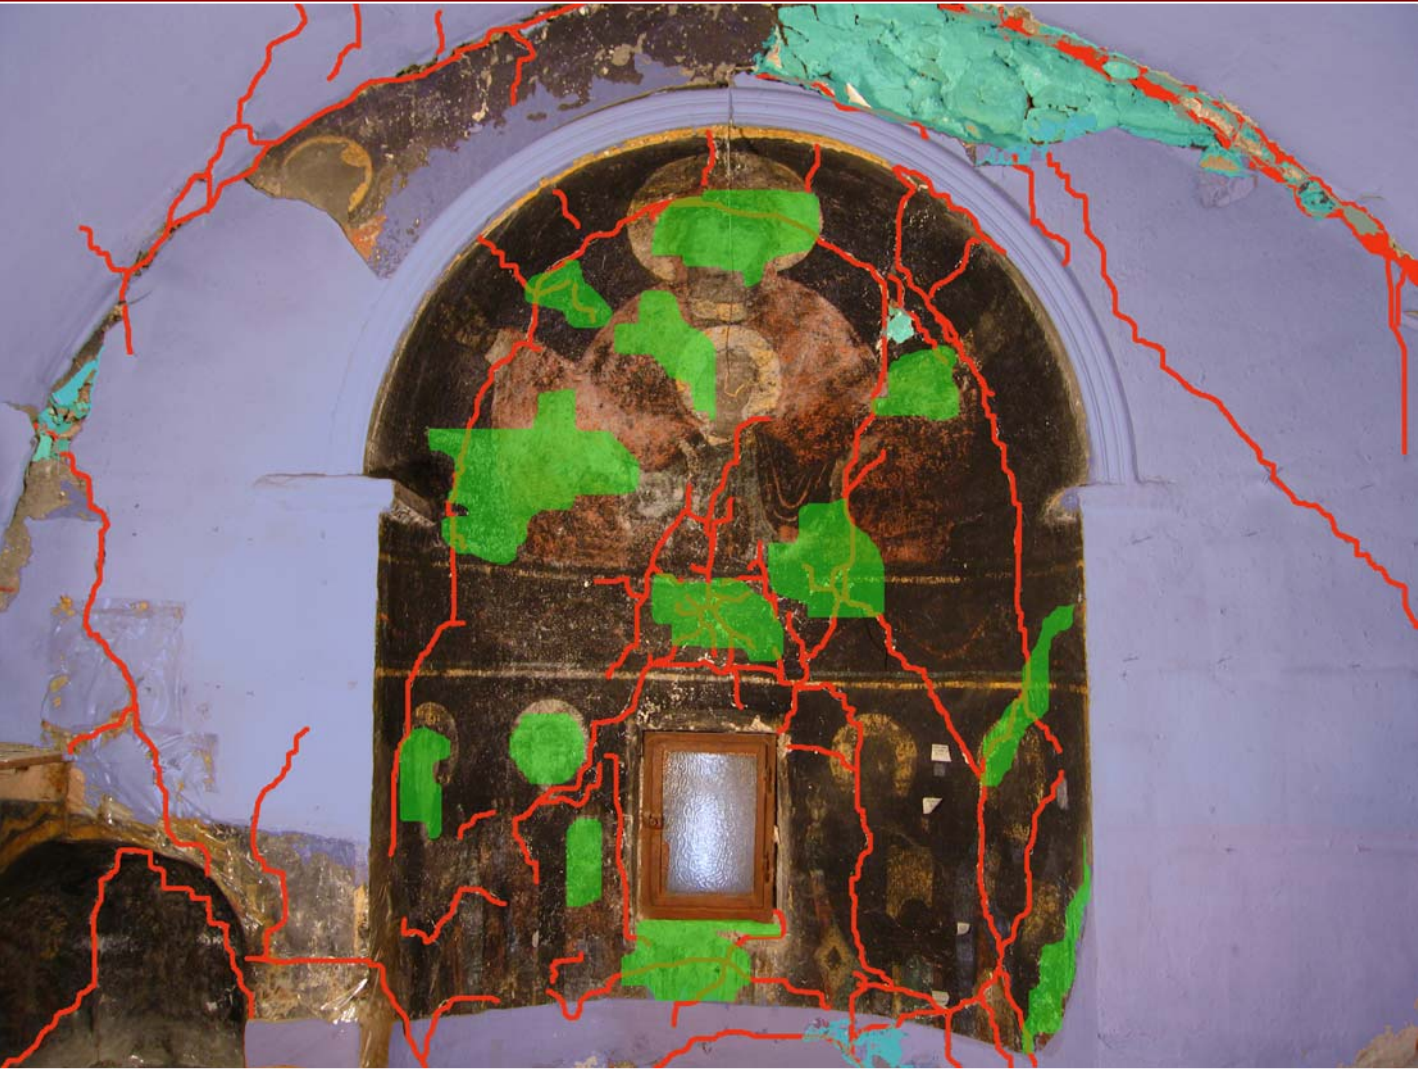
As far as the wall paintings is concerned, they suffered detachment from the supporting wall, losses and structural cracks. Furthermore a great percentage of their surface is covered by a layer of wall plaster of about 2-4 cm thick which is based on cement and lime. The rest of the paintings are covered by a layer of soot produced by burning candles.

- Covering wall plaster
- Substrate cracks
- Flaking paint layer
- Losses

- Removal of the covering plaster using hand tools
- Consolidation of the wall paintings supporting plaster
- Consolidation of the flaking paint layer
- Reinstatement of the cohesion of the wall paintings with the supporting wall by the use of injected consolidating material
- Perimetric stabilisation of the wall paintings by the use of lime plaster
- Reinforcement of the mortars using injected material
- Application of wall plaster on the losses
- Cleaning

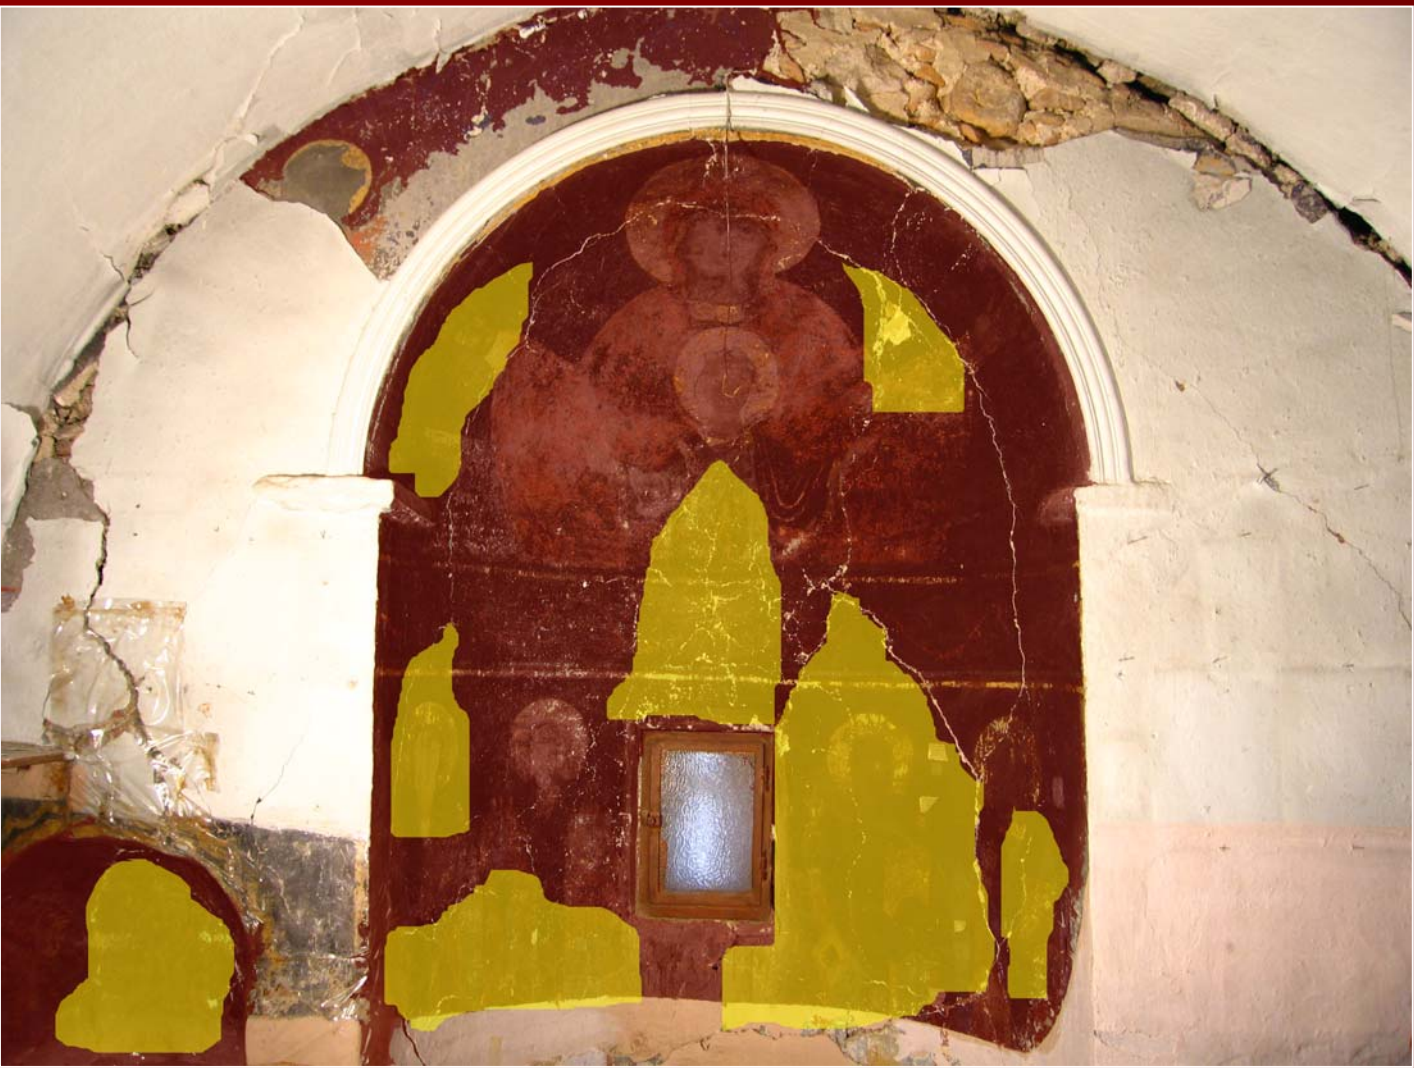
Soot

Detachment from
the supporting wall
