ISR 99

Strategic Intervention for the restoration
of the damages caused by the 1999 earthquake
at the Byzantine church of Aghios Petros
in Eastern Attica, Greece

Subproject's Progress

Athens, 15 & 16 March 2007

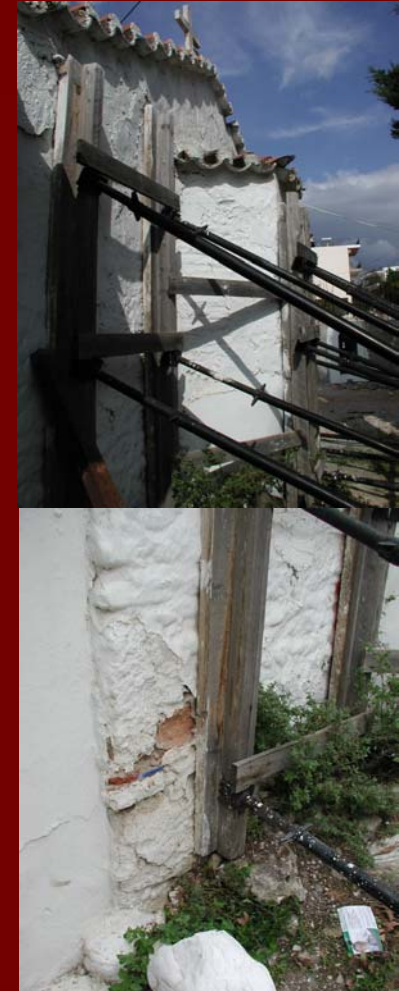
The problems already mentioned in the pathology, are attributed to the following reasons:

- Rather weak, shallow foundation on an inhomogeneous ground (partly due to the close proximity to the nearby creek)
- Poor and mixed quality of the building material
- Later interventions to the building (opening of a door near the corner, removal of one of the western transverse wall) that affected the symmetry and conservative character on which such modest structures rely
- The fairly local, recent (September 1999) earthquake in the region of Mt. Parnitha
